Resource Identifier: Davis Mobile Equipment Facility

- P10. Report Citations:** (Provide full citation or enter "none") A Survey and Historic Significance Evaluation of the CDF
Building Inventory, 1994 Mark V. Thornton

Resource Identifier: Davis Nursery

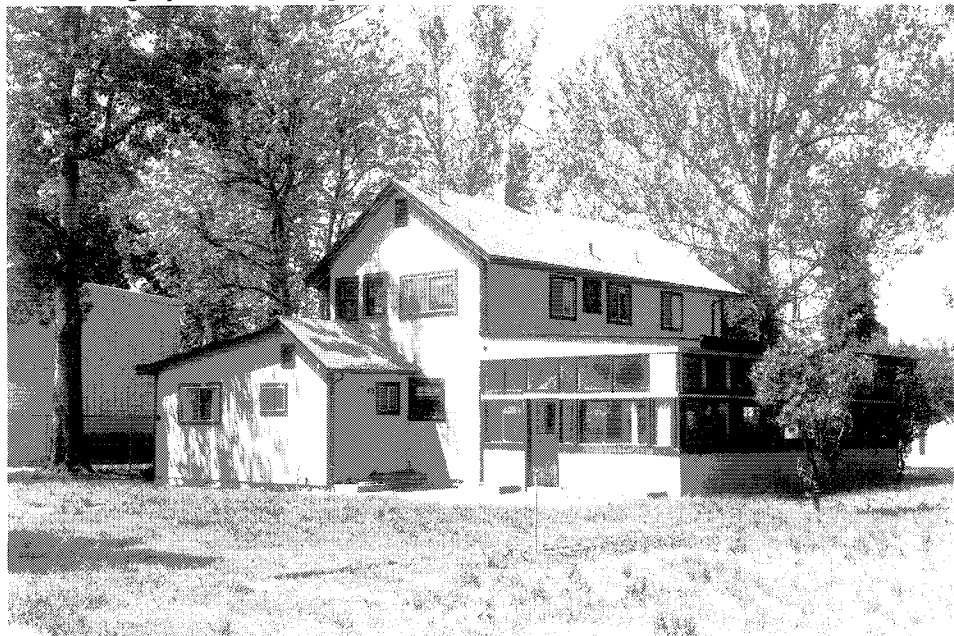
A circa 1935 residence and circa 1937 equipment shed are the only pre-1946 buildings identified at this site. The residence reportedly is a converted barn, which was erected circa 1922. The S-5 Form for the site appears to give a construction date of 1935 for the residence. The house is a two story rectangular wood frame building with asphalt composition shingles over a gable roof. The gable side, front entry is covered by a full width (17' x 33') enclosed concrete patio. The patio enclosure has a shed roof and the wood frame walls feature a row of fixed pane windows just below the cornice. Another row of 1/1/1 (no mullions) wood frame sliding windows is below this upper row. A 1 pane/1 panel entry door is located on the east end. The house has a concrete perimeter foundation, "v" rustic siding, a mixture of older multi-pane double hung wood frame windows and newer 1/1 aluminum frame sliders. Eaves have fascia boards. A rear service porch is located on the west end of the south elevation. A 14' x 25' shed roof addition extends easterly along the south elevation from the service porch. An 8' x 24' room addition has been constructed on the eastern end of the rear addition. It ties in with the rear addition. This later vintage room addition has plywood panel siding. The front patio enclosure and rear additions have asphalt composition, rolled roofing. The house has an internally accessed poured concrete basement. (See continuation page)

East and north elevations of the former ranger's residence.

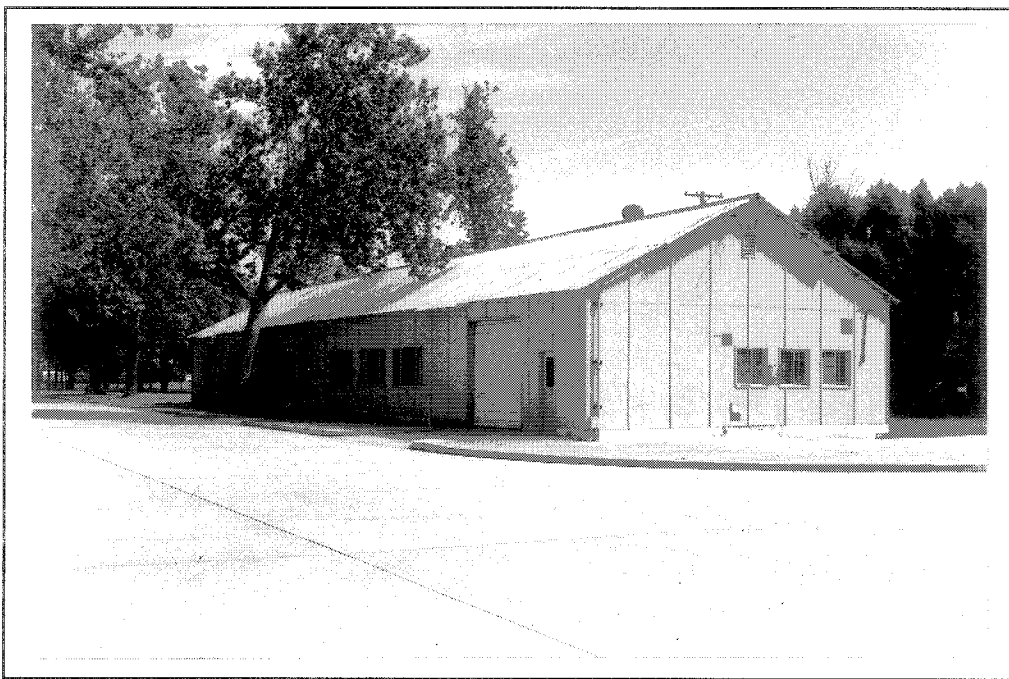
The equipment shed is a rectangular, single story wood frame building. It has a concrete slab foundation, plywood and batten over "v" rustic siding, plain fascia, and corrugated metal panels over a gable roof. The 4,192 square foot building serves as a surplus equipment storage shed. The northeast corner has a small office with 1/1 aluminum frame sliding windows. The south gable end has three 1/1 metal frame casement windows off-set to the right. The west elevation has two overhead aluminum sectional doors asymmetrically placed with three 1/1/1 aluminum frame sliding windows (center pane is fixed) in between. Entry doors have a single upper wire mesh glass pane.

West and south elevations of the equipment shed.

This is the longest equipment shed in the CDF system that predates 1946. The remodeling that took place in the early 1980s has obfuscated its original architectural design. The building is believed to be based on one of the USFS-CCC "N" series working plans. Due to the extensive revisions, it has lost much of its historic integrity.

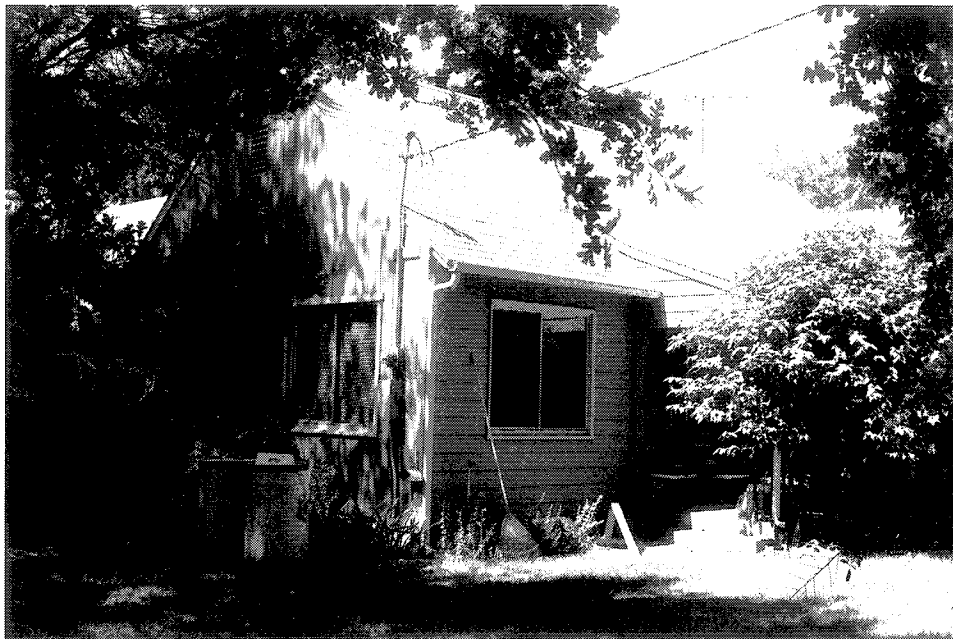
The Davis Nursery has a large collection of buildings. The oldest building is a single story residence located toward the east end of the compound. The house was constructed circa 1921 and has been moved twice in the intervening years. The 1,462 square foot building has a concrete perimeter foundation, 1/1 aluminum frame sliding windows, plain fascia, and asphalt composition shingles. Siding on the front elevation is lapboard, all of the other walls are clad with plywood paneling. The gable side, front entry is recessed under an extended shed roof which is supported by wrought iron posts. This roof covers a small entry porch. A small gable front wing bounds the porch on the right. Another gabled cross wing is located on the southeast corner of the house. This rear elevation addition has a hip roof covered, enclosed porch located gable end. A small concrete patio is on the south side of the house. An associated circa 1940 garage stands to the southwest of the house. It features a concrete slab foundation, "v" rustic siding, and a simple gable roof. The two stall gable end entry has a single double wide garage door. The yard around the house and garage is landscaped with lawn, shrubs, and trees. Near the entrance to the nursery is a circa 1940 barn. It has a concrete slab foundation, drop board and batten siding, open eaves, and corrugated metal paneling over a gable roof. (see continuation page)

Northeast side of the state residence.

Circa 1922 house relocated 1940 to make way for road construction, moved again 1959 to make way for the Highway 40 (Interstate 80) construction project (reference CDF Plan 4452 SC). Fenestration is basically original. The windows and siding were replaced in the 1980s. A rear addition on the west end has been removed. A rear addition was constructed circa 1988 on the east end. Front porch posts replaced and other revisions, dates unknown.

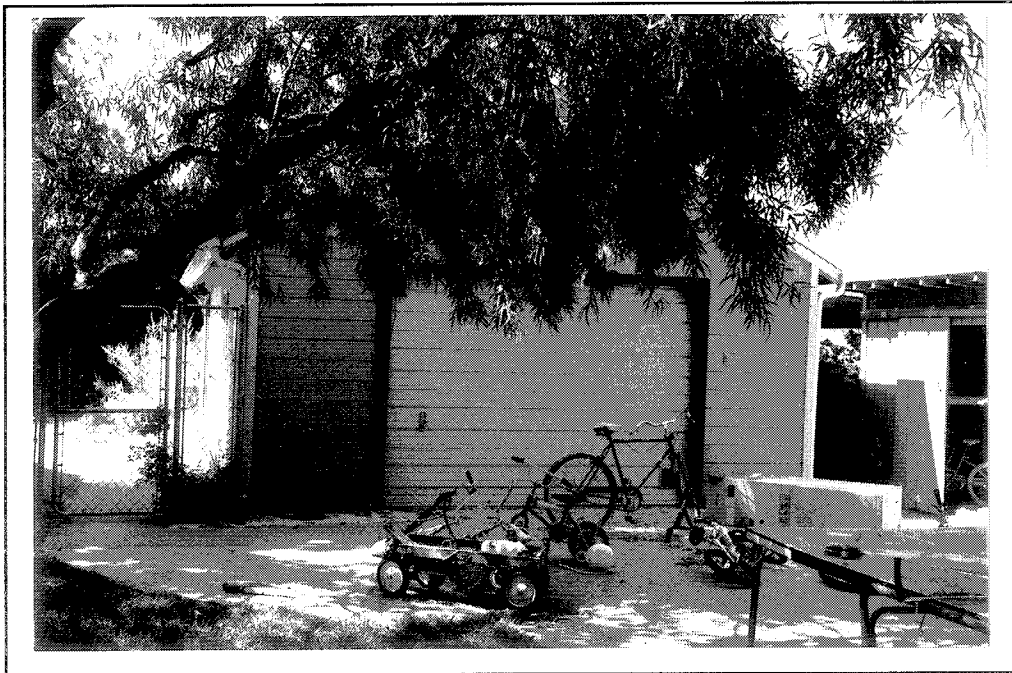
North elevation of the residence garage.

Minor cosmetic alterations, two stall entry converted to single double wide entry, date(s) unknown.

The S-5 Form lists an 18' x 28' garage constructed 1940. This is believed to be that building. It would have been moved in 1959 along with the associated house. The building's design conforms to the USFS-CCC "J" type residence garages constructed at fire stations and ranger stations in the 1930s. A similar building with higher historic architectural integrity is located at the San Andreas Ranger Unit Headquarters.

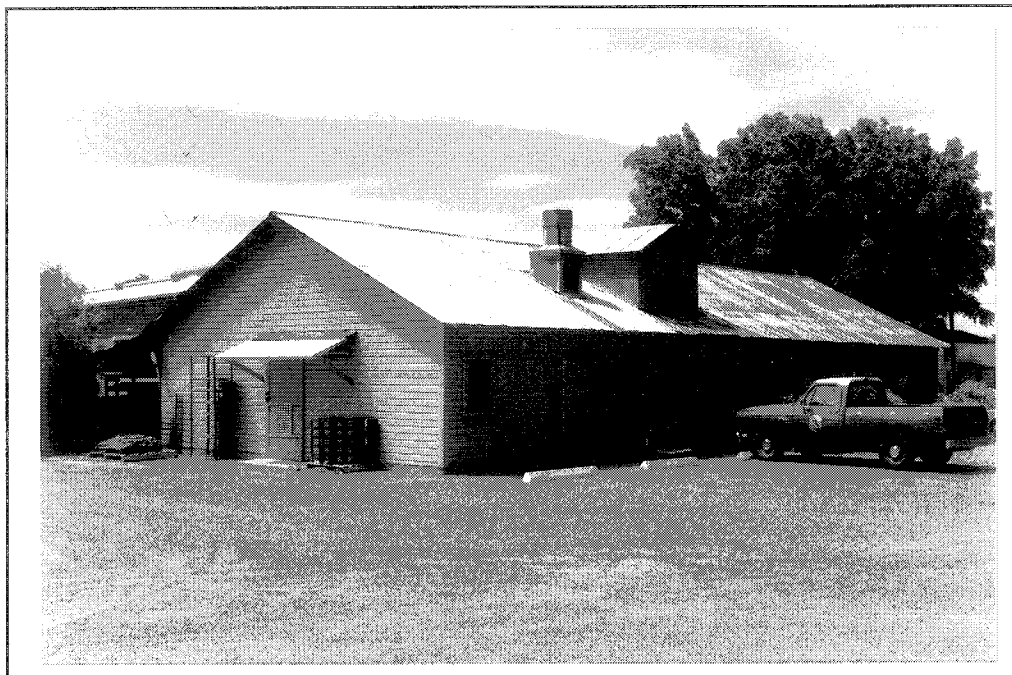
The 2,700 square foot barn was originally 50' x 31' but a 10' x 50' shed roof west addition and a 31' x 25' gabled south addition have been added. A 24' by 10' shed roof shelter is on the south end of the west addition (west of south addition). This shelter is open on the south and has a row of fiberglass panels along the west wall. A cantilevered shed roof shades the south gable end entry to the barn. An overhead track sliding door is located on the north gable end, with hinged double doors located in the gable above. A gable "dormer" unit on the east slope of the roof marks the location where an internal elevator mechanism (for seed transport) once existed. A former 1952 house and garage, now office and conference room, are east of the barn. A number of newer vintage nursery buildings are to the south and west.

South and east elevations of the barn.

Original circa 1940 barn enlarged prior to 1952 with 11' x 50' west addition (for housing refrigeration equipment) and 31' x 25' south gable end addition.

This is the only pre-1946 barn in the CDF collection included in this report. Some sources indicate this barn was constructed of salvaged material from older nursery buildings. Under this scenario, the building was reconstructed by the CCC in the late 1930s. The barn consists of three sections which appear to be of different ages. The original section (50' x 31') may be based on one of the USFS-CCC construction era "M" series designs. Based on appearance and various site maps, the additions are believed to have been in place by 1952. The building does maintain a degree of its historic character.
